**Ruth Inch Memorial Pool  
Building Condition Assessment  
– Phase 1**

Building Condition Assessment

Stantec File: 144903431

Report Date January 22, 2024

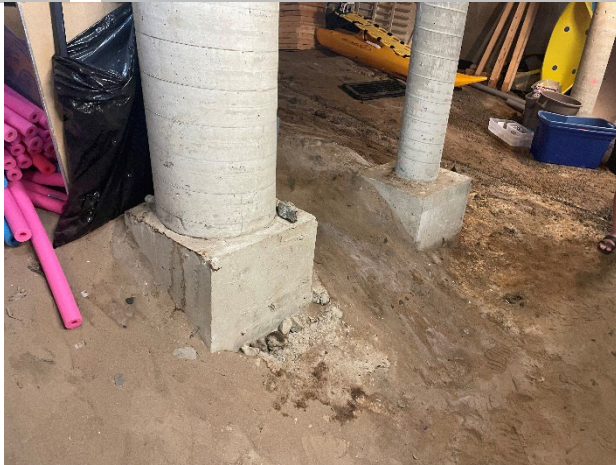
Crawlspace Foundation Piers

All visible foundation elements bearing on the bedrock appeared to be in very good condition with no signs of failure or damage.

No recommendations.

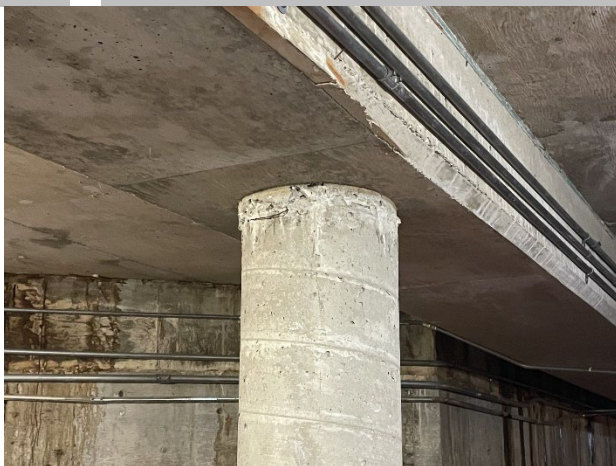
Crawlspace Columns

All visible columns supporting the main floor slab appeared to be in good condition. It was noted that many of the column tops showed minor signs of spalling and moderate-to-severe honeycombing. The honeycombing would be a result of construction defects and does not seem to be impacting the performance of the member.

No recommendations.

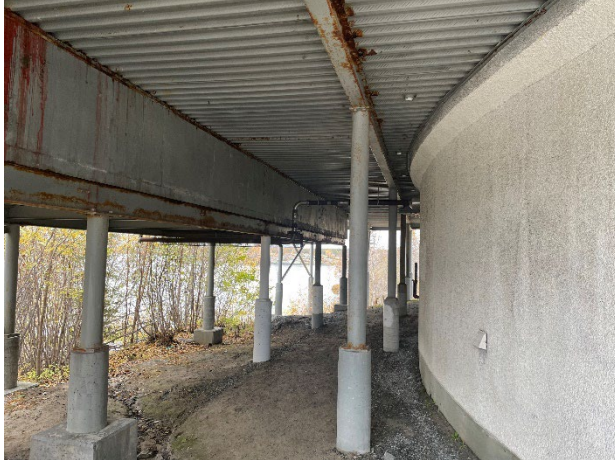
Rear Deck Foundation Piers and Columns

All visible columns and piers supporting the rear deck (facing Frame Lake) appeared to be in good condition. It was noted that many of the columns are showing signs of moderate-to-severe rust. Also See Section B1010.

It is recommended that the exterior steel columns be stripped of existing paint/finish and refinished with a polymer or epoxy-based coating.

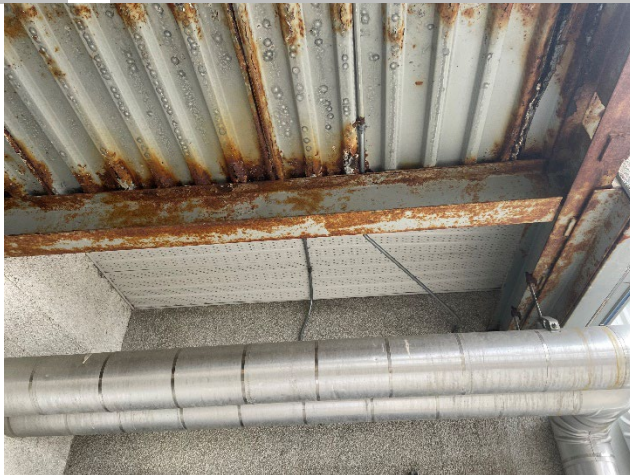
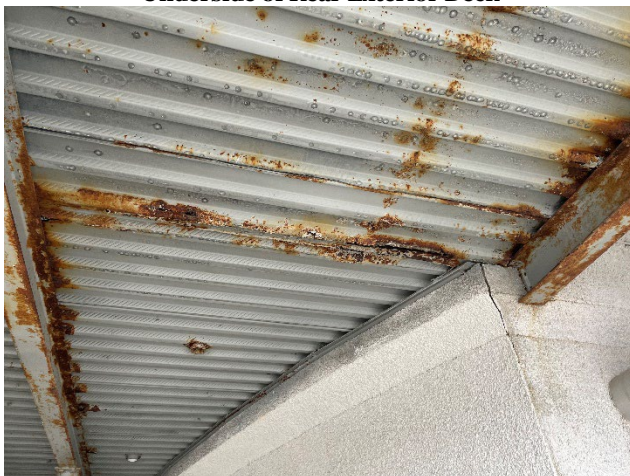
Underside of Rear Exterior Deck

<b>Remaining Service Life</b>	Less than 5 Years
<b>Action Priority</b>	Mandatory
<b>Rating</b>	Unsatisfactory

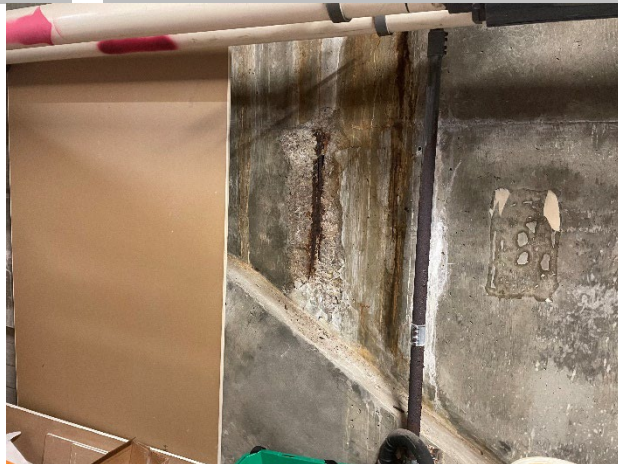
**Pool Tank Wall – Exposed Reinforcement**

**Remaining Service Life** Less than 5 Years

Therefore, as a minimum, we recommend that the any loose concrete be removed and scaped down to solid material. All corroded/exposed reinforcement should also be cleaned and then the wall patched with a cement-polymer/epoxy grout patch/filler product.

Note: If it is not possible to clean the reinforcement, a surface mount reinforcement plan will need to be considered. This will require a specific engineered design.

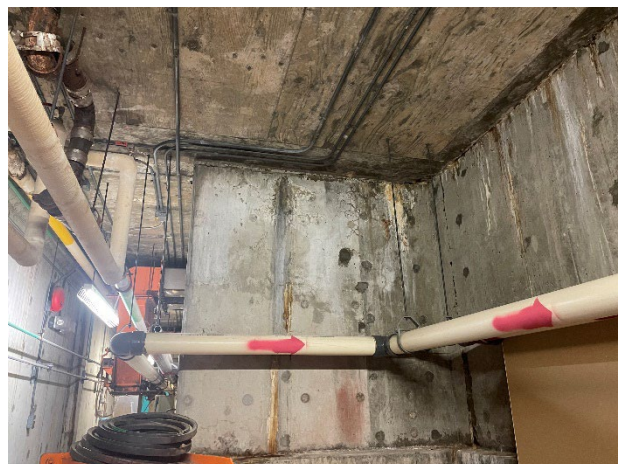
**Pool Tank Wall – Spalling and Corrosion**

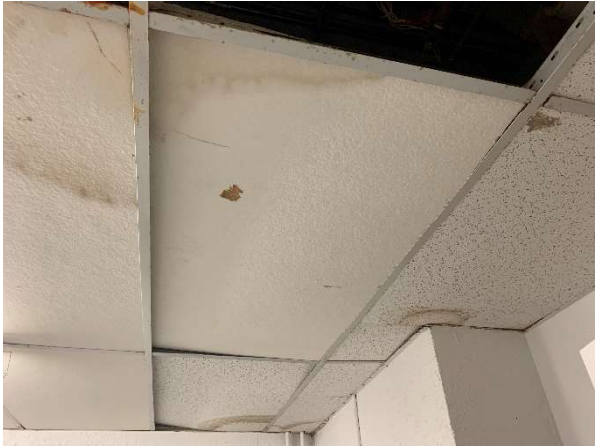
Building Area	Observation	Suspected Source of Moisture	Photo
Lower level, staff room	Moisture-stained ceiling tiles in lower-level staff room	Pipe leak

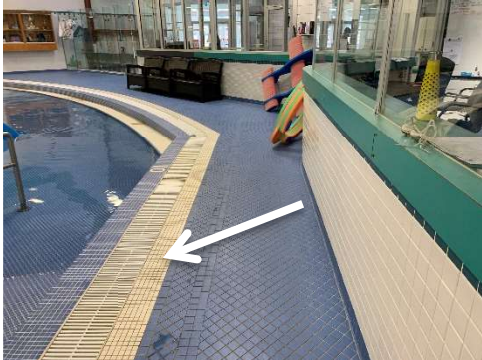
Identified ACM Description and Condition Information	
<b>Products associated with white ceramic tiles (e.g. grout and adhesive) applied to pool deck floor</b>	
% Type	PACM
Friability	Non-friable
Condition	Good

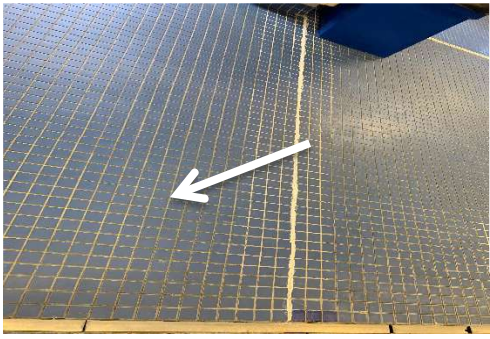
<b>Products associated with blue ceramic tiles (e.g. grout and adhesive) applied to pool deck floor</b>	
% Type	PACM
Friability	Non-friable
Condition	Good

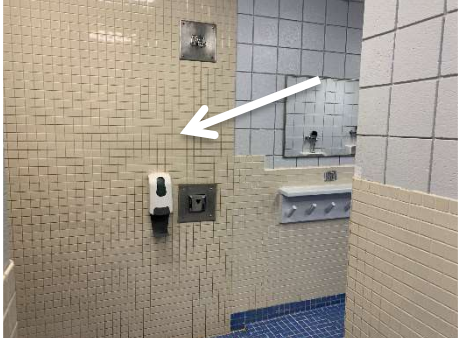
<b>Products associated with beige ceramic tiles (e.g. grout and adhesive) applied to walls throughout upper floor change rooms</b>	
% Type	PACM
Friability	Non-friable
Condition	Good

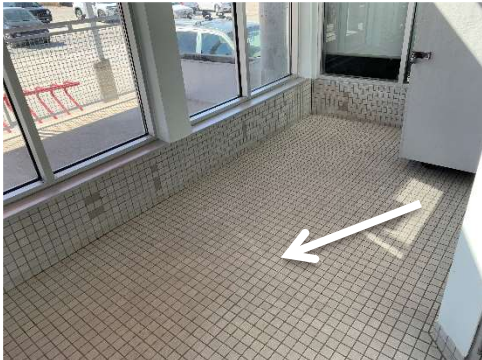
Identified ACM Description and Condition Information	
<b>Products associated with grey ceramic tiles (e.g. grout and adhesive) throughout upper floor lobby</b>	
% Type	PACM
Friability	Non-friable
Condition	Good

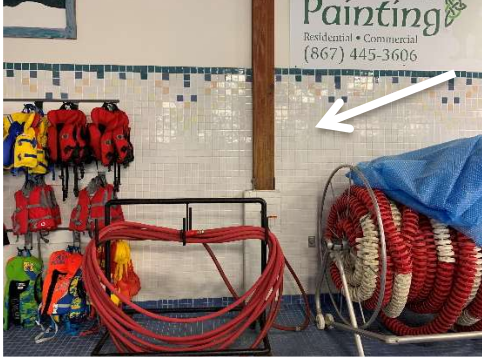
<b>Products associated with mosaic ceramic tiles (e.g. grout and adhesive) applied to walls throughout pool deck</b>	
% Type	PACM
Friability	Non-friable
Condition	Good

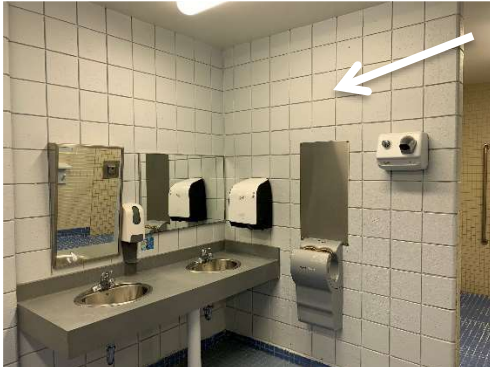
<b>Brick mortar associated with white 8x8' block walls throughout upper floor changerooms</b>	
% Type	PACM
Friability	Non-friable
Condition	Good

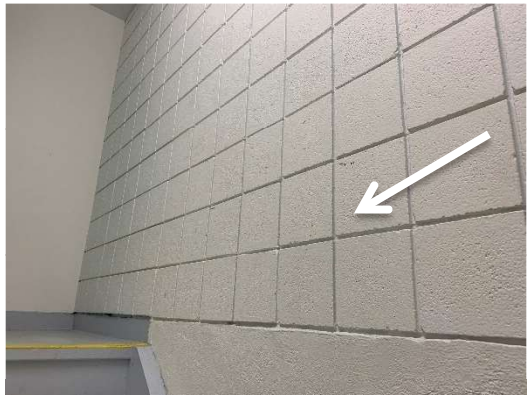
Identified ACM Description and Condition Information	
<b>Vermiculite insulation (if present) within block walls throughout</b>	
% Type	PACM (destructive testing required to confirm presence/absence).
Friability	Friable
Condition	Good

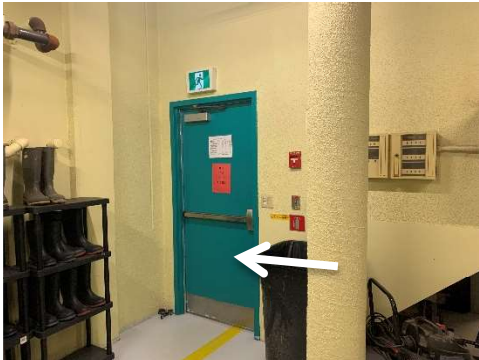
Substrate	Metal	
Location/approx. extent	Applied to doors throughout	
Lead content	1,600 ppm	
Condition	Good	
Paint colour	Red

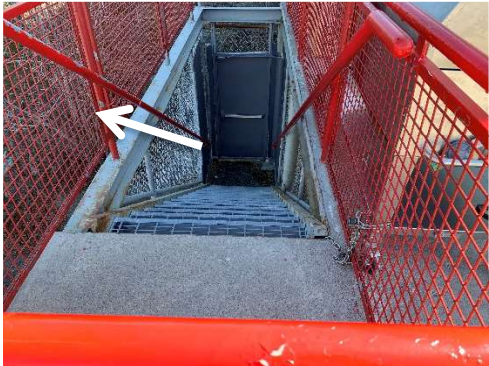
Substrate	Metal	
Location/approx. extent	Applied to railings and trim throughout exterior	
Lead content	2,200 ppm	
Condition	Good with localized damage (sundeck railing flaking and chipping in some sections)
