**Ruth Inch Memorial Pool  
Building Condition Assessment  
– Phase 1**

Building Condition Assessment

Stantec File: 144903431

Report Date January 22, 2024

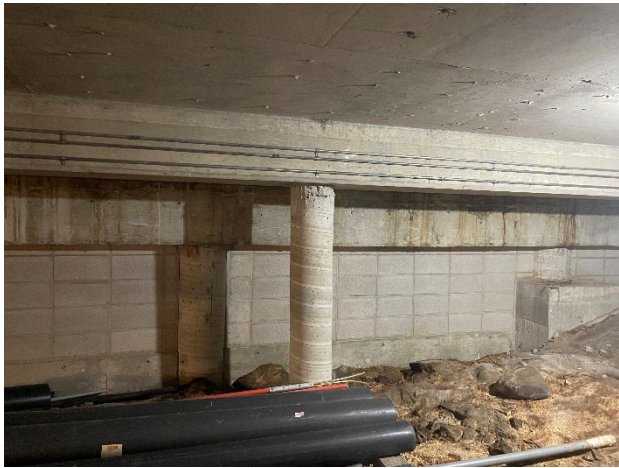
**Underside of Main Floor in Crawlspace**

From what could be observed from below, most of the main floor structure, including supporting columns, appeared to be in very good condition. The floor slab and beams show no signs of distress or failure with no significant cracking or spalling.

One area of minor concern is the discoloration of the slab near the pool tank. This is limited to within one metre (or less) of the tank-to-wall interface. Though it is discolored, no spalling or exposed reinforcement was observed.

No recommendations.

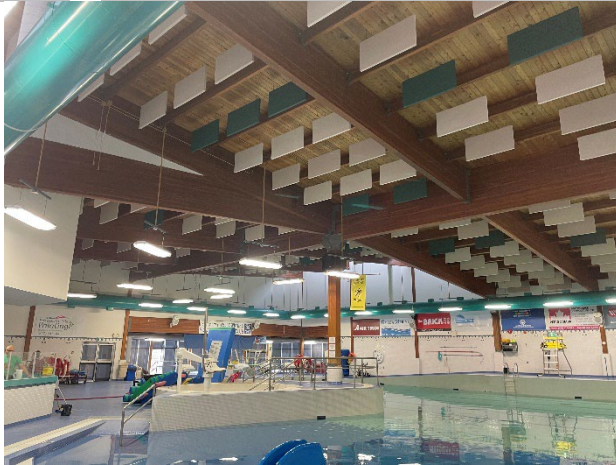
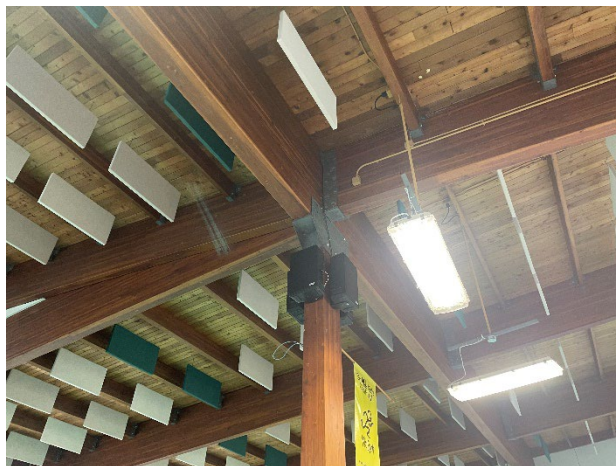
Roof Over Pool Tank

All visible roof members, including supporting columns and roof decking, appeared to be in very good condition. Given the age of the structure, the glulam construction, and the high humidity it is quite surprising to see this level of structural performance. No splitting or delamination was noted in any of the glulam members and the steel connections we most clean and free of corrosion.

One cosmetic item to note was some staining on the a few of the glulam members. This is likely due to past water infiltration from possible failure of the architecture roof assembly. The structural integrity of these members does not appear to be affected at this time.

It is suggested that these areas be cleaned and refinished. Refer to the upcoming Architectural assessment for final recommendations.
